## Nottingham Express Transit deal with contaminated land

### Case Record

Location	Nottingham
Client	Greater Nottingham Rapid Transport
Designer	Maunsell, Parsons, Brinkerhof
Construction	Carillion Construction
Track Laying	Carillion (Centrac)
Tram provision	Adtranz
Operations & Maintenance	Transdev/NCT

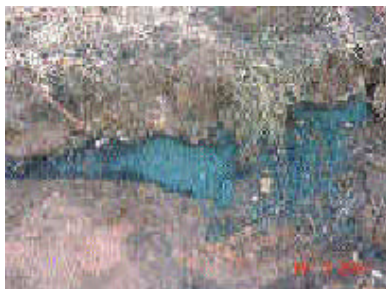
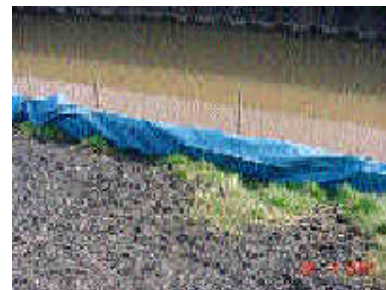
Previous assessments of historical maps and the completion of a geo-hydrological survey confirmed that the site had been used as a dumping facility and had caused large areas of contamination. Three main types of waste material were initially identified, demolition and excavation waste, soap manufacturing waste and gas works waste.

Clearance of the vegetation cover was then undertaken, with surface deposits of Blue Billy being easily identified. Lighter coloured fencing was then used to isolate the contaminated areas and differentiate them as contaminated. A decontamination unit (consisting of 'contaminated area', 'shower area' and 'clean area') was also provided to safeguard the welfare of all staff and operatives working on the site. Finally a wheel wash with high-pressure self contained washing apparatus was established at the site boundary to ensure all vehicles leaving the site passed through.

The most common contaminant found is a cyanide compound, 'Blue Billy.' This was easy to recognise because of its bluish-green colour and was by far the most hazardous pollutant found on the site containing elevated concentrations of arsenic, cadmium, lead, mercury, sulphur and phenols.

The contaminated ground was replaced with clean soil and sowed immediately with rye grass to limit impact of run-off, with precautionary measures still in place on-site until the grass has fully grown.

So far 2400 tonnes of contaminated material have been removed and sent to a special landfill site in Rotherham by haulier. Trucks with the contaminated loads were followed on several occasions to ensure procedures were being implemented.
